DEPARTMENT OF TRANSPORTATION

Contract #: 04-0120F4Cty: SF/ALA Rte: 80 PM: 13.2/13.9File #: 69.28**WELDING INSPECTION REPORT****Resident Engineer:**Siegenthaler, Peter**Address:** 333 Burma Road**City:** Oakland, CA 94607**Report No:** WIR-021752**Date Inspected:** 13-Mar-2011**Project Name:** SAS Superstructure**OSM Arrival Time:** 700**Prime Contractor:** American Bridge/Fluor Enterprises, a JV**OSM Departure Time:** 1900**Contractor:** Zhenhua Port Machinery Company, Ltd (ZPMC), Changxing Island **Location:** Shanghai,China**CWI Name:** Lv Li Qing /Liu Hua Jie**CWI Present:** Yes No**Inspected CWI report:** Yes No N/A**Rod Oven in Use:** Yes No N/A**Electrode to specification:** Yes No N/A**Weld Procedures Followed:** Yes No N/A**Qualified Welders:** Yes No N/A**Verified Joint Fit-up:** Yes No N/A**Approved Drawings:** Yes No N/A**Approved WPS:** Yes No N/A**Delayed / Cancelled:** Yes No N/A**Bridge No:** 34-0006**Component:** OBG**Summary of Items Observed:**

WELDING INSPECTION REPORT

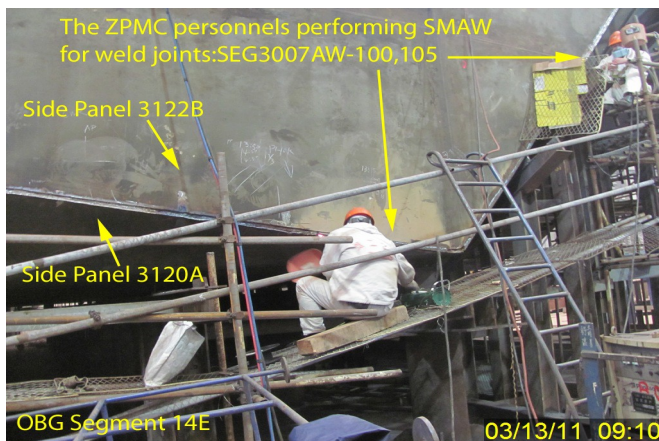
SMAW in the 2G position for the OBG Segment 14E Side panel to Side panel. The weld joint was designated as: SEG3019AW-100. The welder is identified as #070007. ZPMC QC is identified as Mr. Zhan Hai Feng. The welding variables recorded by QC appear to comply with WPS-B-P-2212-TC-U4B-FCM-1. Please see the attached picture.

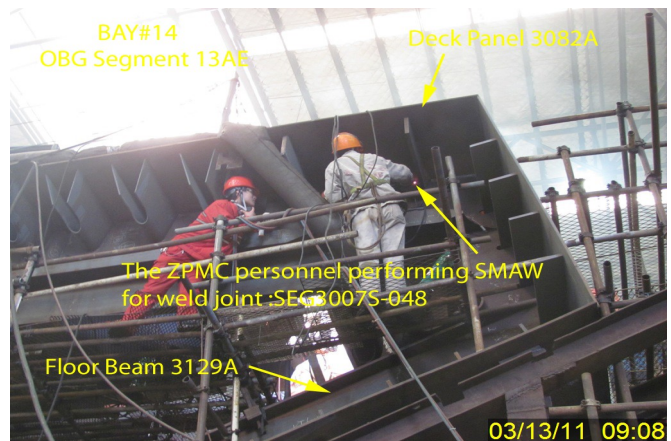
SMAW in the 4G position for the OBG Segment 13AE Deck panel to Edge panel. The weld joint was designated as: SEG3007AB-096. The welder is identified as #068097. ZPMC CWI is identified as Mr. Liu Hua Jie. The welding variables recorded by QC appear to comply with WPS-B-P-2214-TC-U4B-FCM-1. Please see the attached picture.
